FOUR TIMES THE LINER LIFE WITH IMPROVED OVERLAY PLATE

Location:	Western Australia	Mine Type:	Iron Ore Mine
Machine:	Scrubber Discharge Chute	Product:	SPOT60 Wear Plate

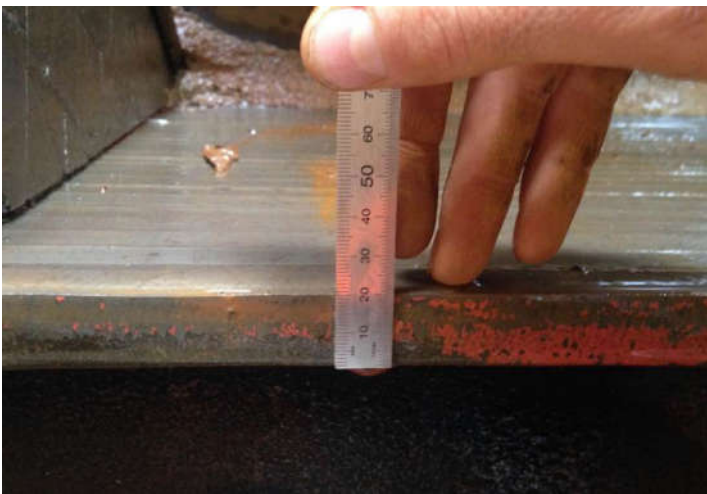
SPOT 60 OVERLAY LINERS AFTER 2 WEEKS – NO WEAR

It was recommended improving the material selection by replacing the existing overlay plate with SPOT60 overlay liners, which are composed of one of the highest wear resistance materials produced in the world today.

- The SPOT60 overlay liners exceeded the life of the competitor’s plate with only 2.5mm wear on the leading edge after 12 weeks,
- The plant extended maintenance shutdowns to every 38 weeks, instead of 12 weeks.
- Significant reduction in the exposure to health and safety risks due to the reduced frequency of repairs.
- The hire of a 250 to 300 tonne crane every 12 weeks is now required once every 48 weeks.
- The client estimates a saving of \$600,000 in combined labour and crane hire, with the relief on maintenance resources alone expected to be around 300 hours per annum.

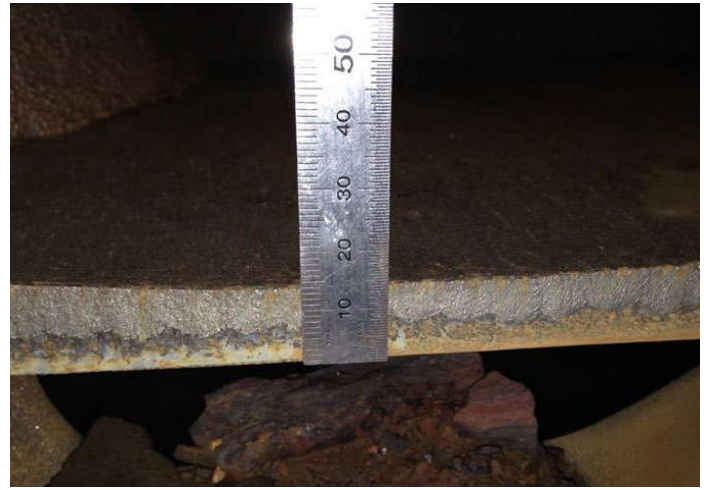
COMPETING PLATE AFTER 2 WEEKS – 4MM OF WEAR

At an iron ore mine located in Western Australia, the customer had an ongoing issue with high wear rates in their scrubber discharge chutes. During each shutdown in a 12 week shutdown cycle, the existing 20mm alloy-chromium carbide overlay plate supplied by a competitor was found to be completely worn through, resulting in damage to the exposed parent metal of the chute.
